J Dewey Property Inspection

8922 E SUnlake Blvd North
Sun Lakes, AZ 85248

Prepared for: Cole, Thomas

Prepared by: J. Dewey Property Inspections

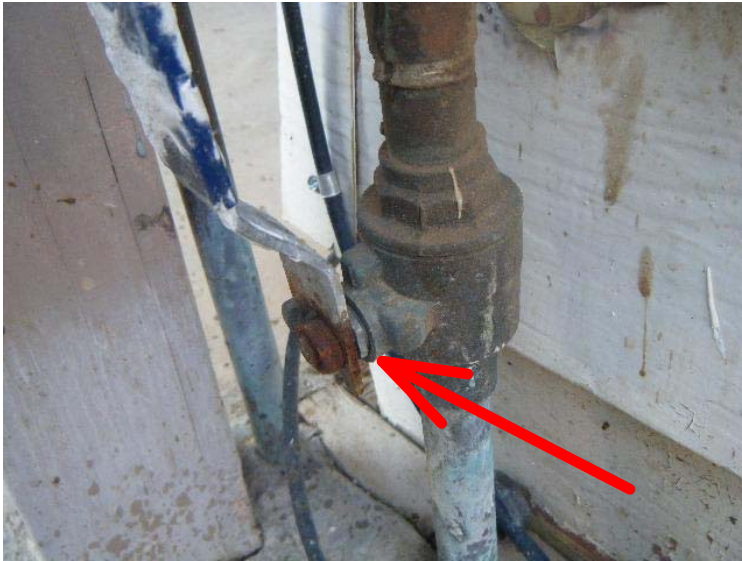
Leaks at main water valve, A licensed plumber is recommended to evaluate and estimate repairs before the close of escrow.

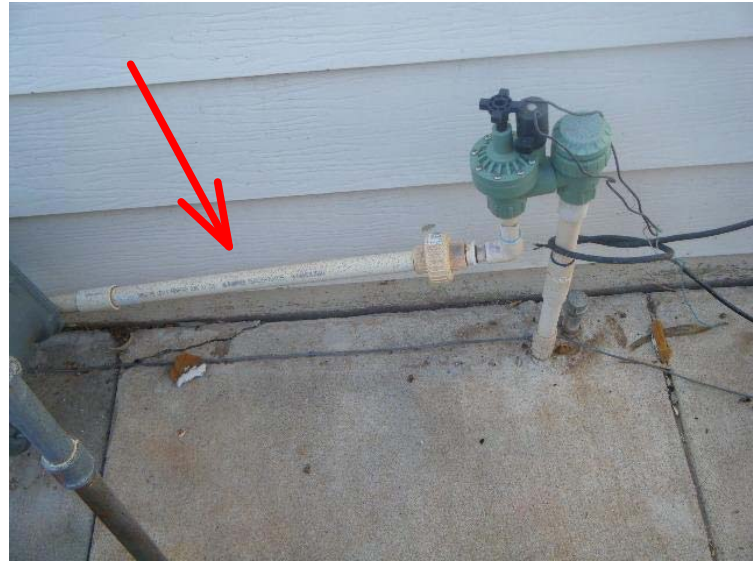
Sprinkler system has been disconnected

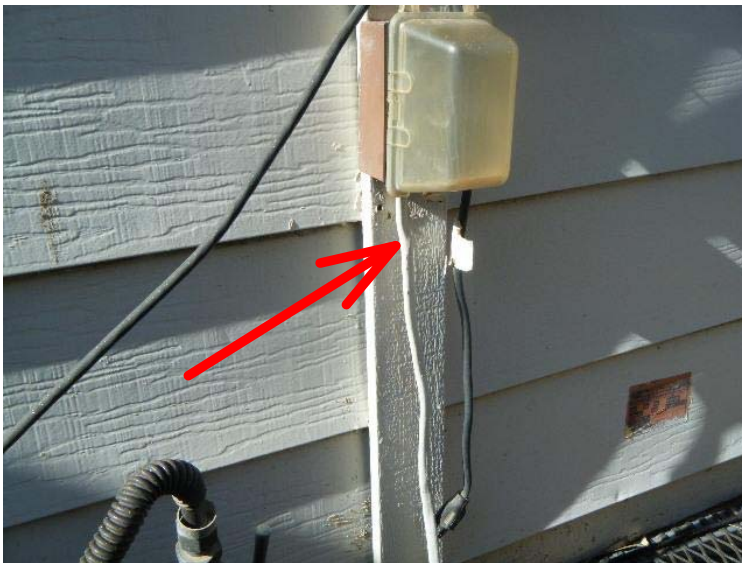
NO EXTERIOR OUTLETS ARE GFCI PROTECTED, All exterior outlets should be GFCI protected since 1973, Outlet at the front of the home also should have had wiring ran in conduit. Evaluation by a licensed electrician is recommended before close of escrow

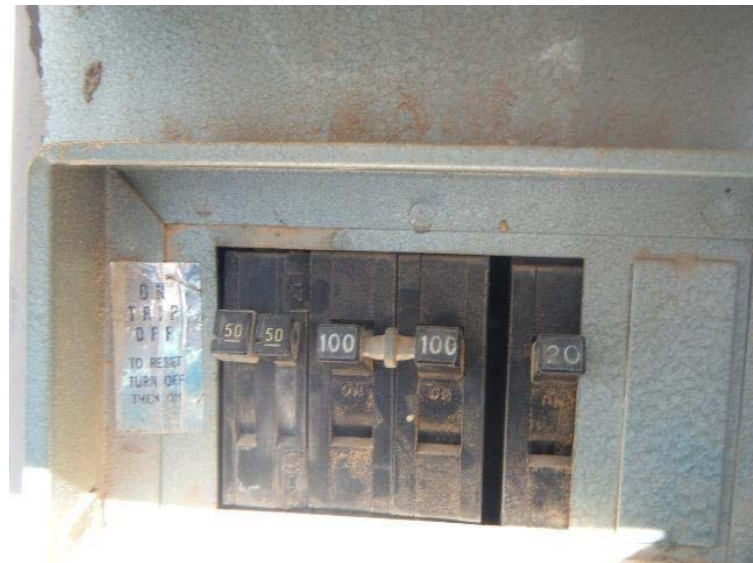
Breakers are not all labeled they should all be labeled at the main post and sub panels

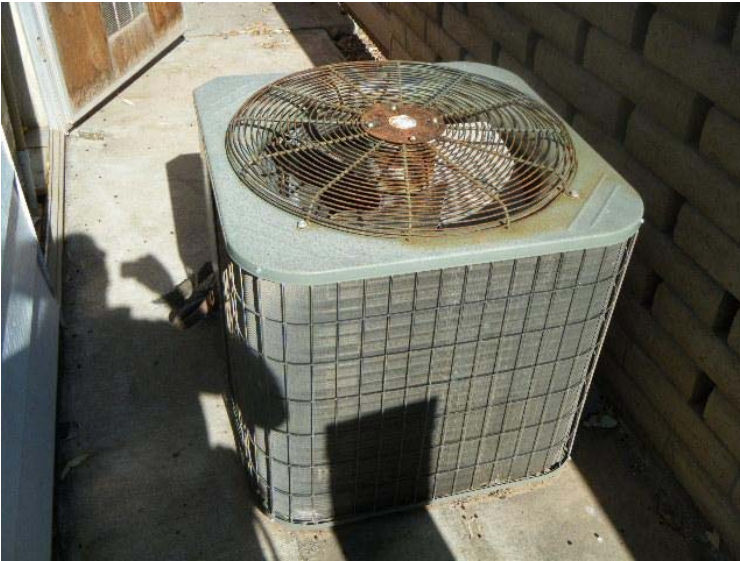
AC System and Air handler / blower would not cycle on, A qualified air conditioning contractor is recommended to evaluate before the close of escrow.

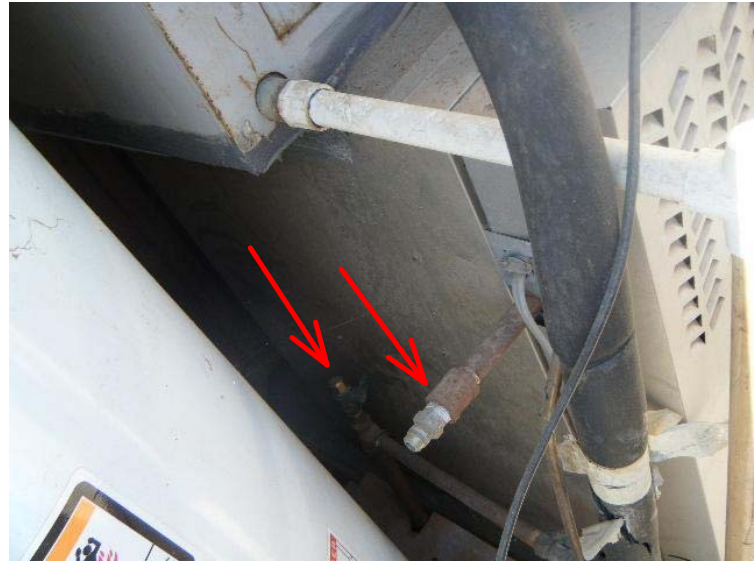
Air handler / blower would not cycle on and the gas is disconnected, , A qualified air conditioning contractor is recommended to evaluate before the close of escrow.

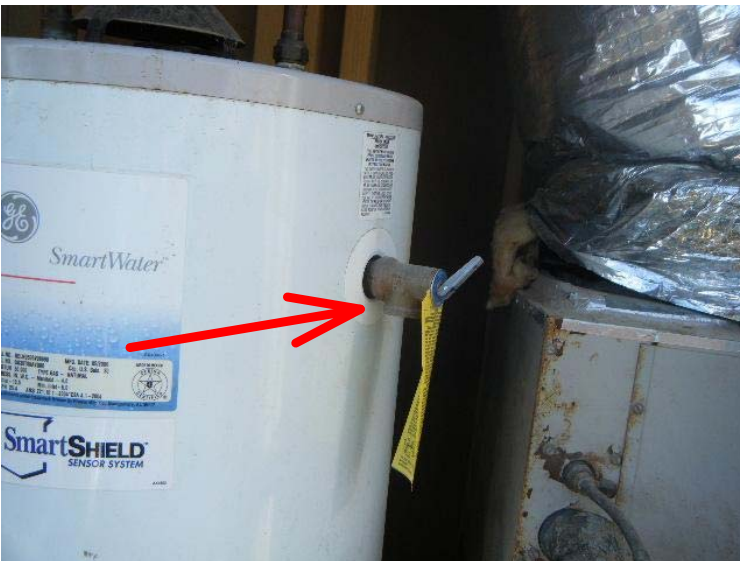
Missing drain tube from TPR valve does not exit to exterior of house SAFETY ITEM, A licensed plumber is recommended to evaluate and estimate repairs before the close of escrow.

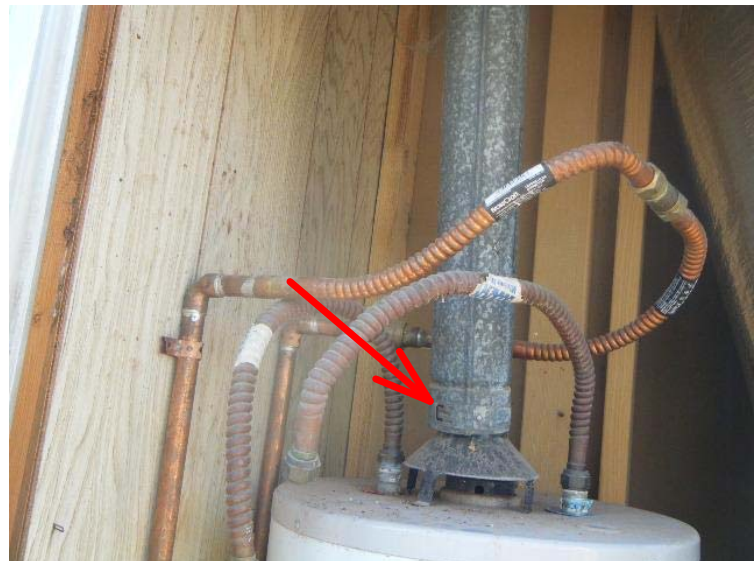
Water heater is disconnected from the water supply and there is a not stating improper venting from the gas company, A licensed plumber is recommended to evaluate and estimate repairs before the close of escrow.

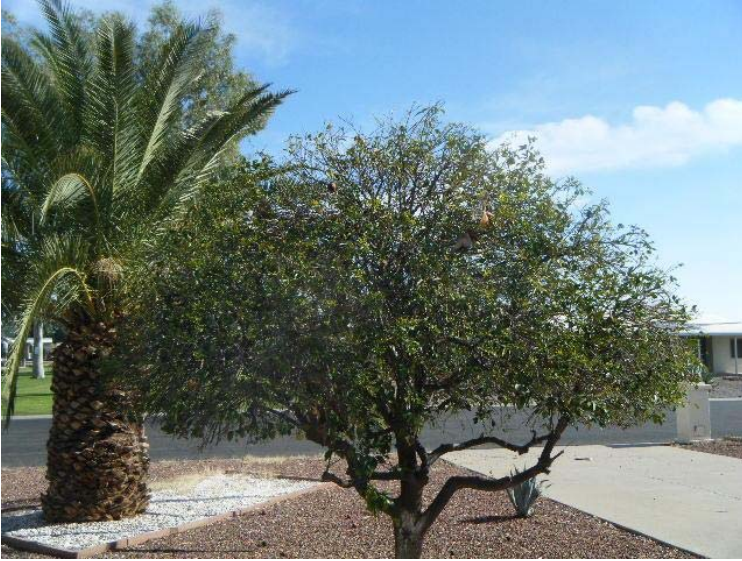
There are shrubs or trees that appear to be stressed from a lack of water they may or may not recover I have no way of knowing.

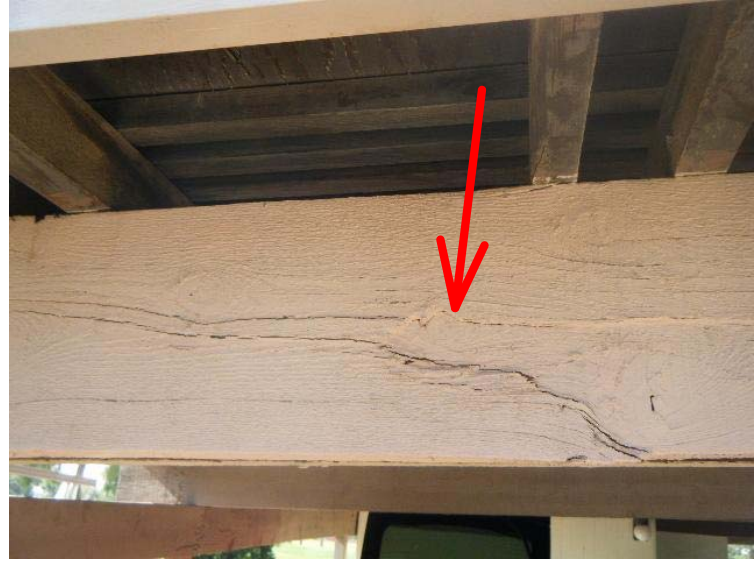
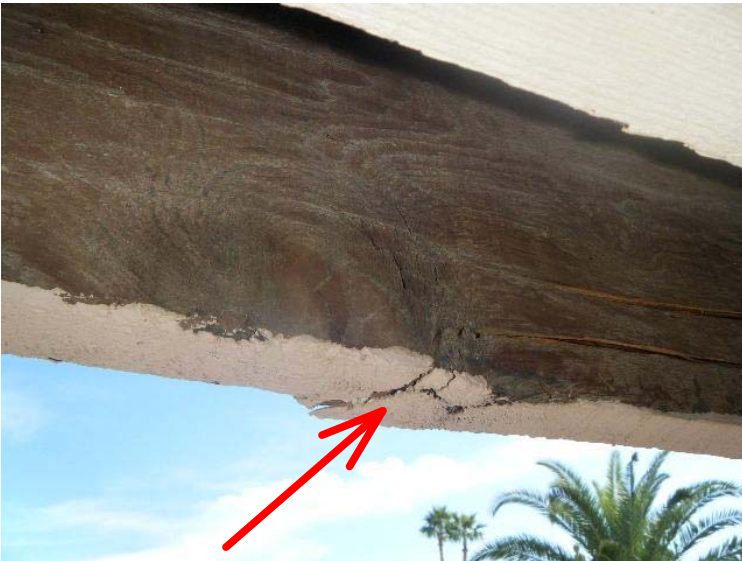
Front beam at carport has cracked slightly sagging areas, A qualified roofing contractor is recommended to evaluate and repair before the close of escrow

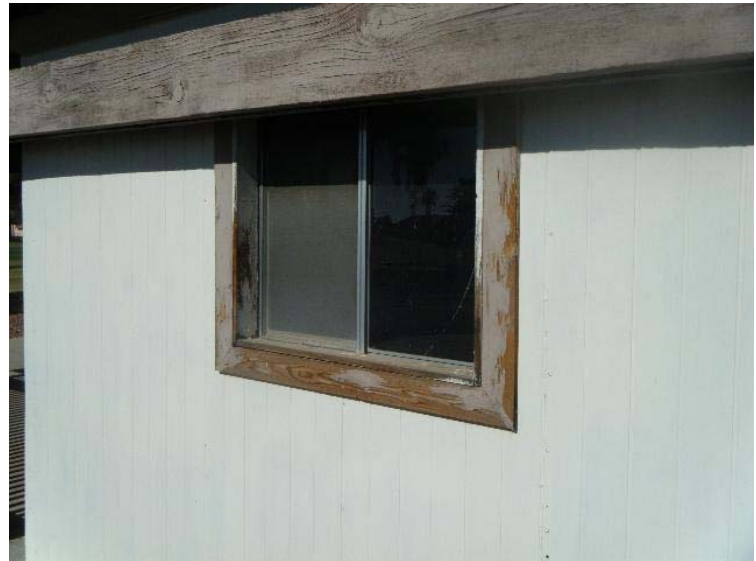
Paint peeling at areas around the shed

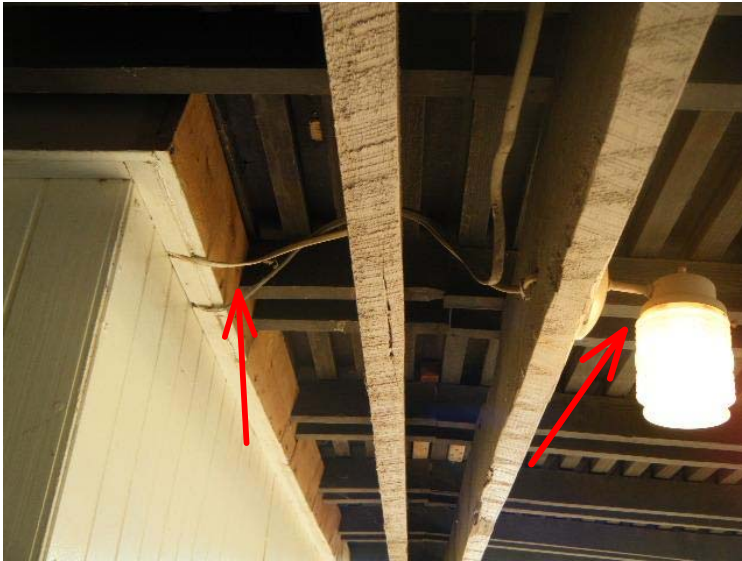
Light at the rear of the carport should have had wiring ran in conduit. At the northwest patio door there is no exterior light. Exterior lighting is typically found at each exterior door and may be a city code requirement. Evaluation by a licensed electrician is recommended before the close of escrow.

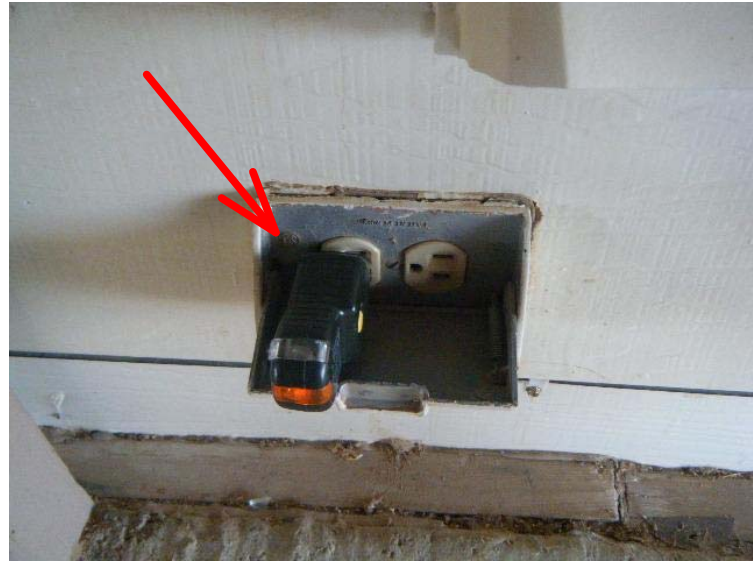
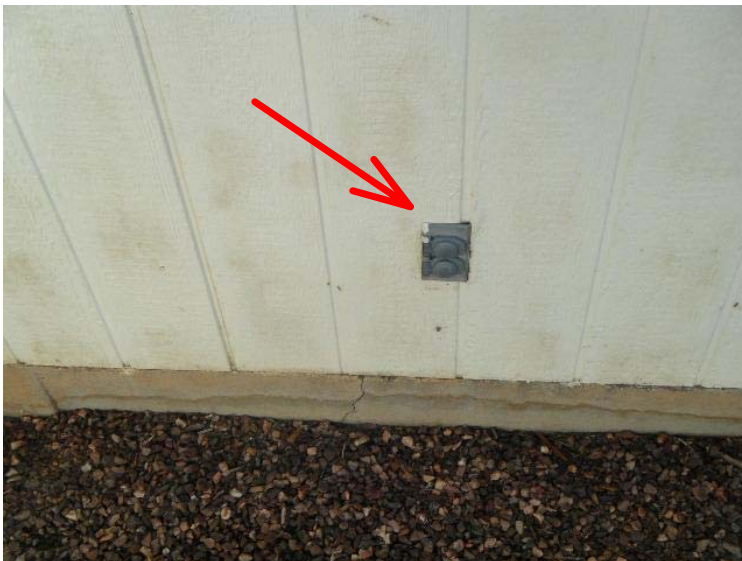
NO EXTERIOR OUTLETS ARE GFCI PROTECTED, All exterior outlets should be GFCI protected since 1973. Outlet at the front of the home also should have had wiring ran in conduit. Evaluation by a licensed electrician is recommended before close of escrow.

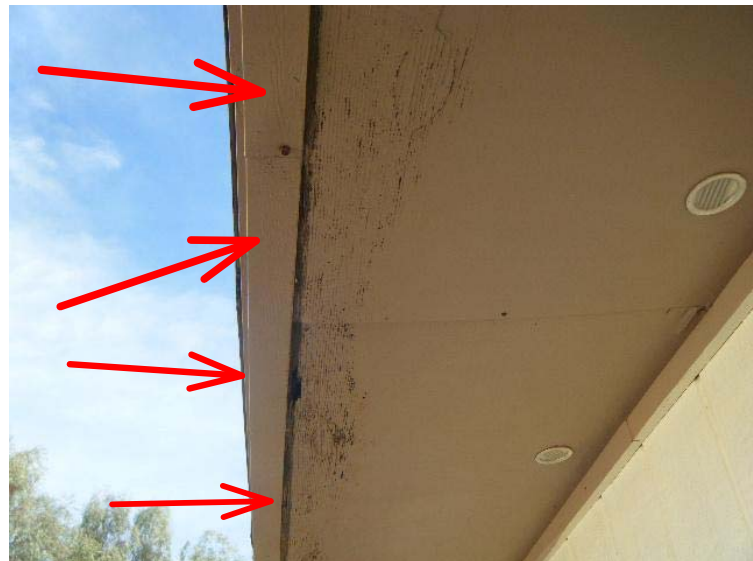
Along the northeast side of the home there are areas with moisture damage and wood rot. There are a few other small stained areas also. A qualified contractor is recommended to evaluate and estimate repairs prior to close of escrow.

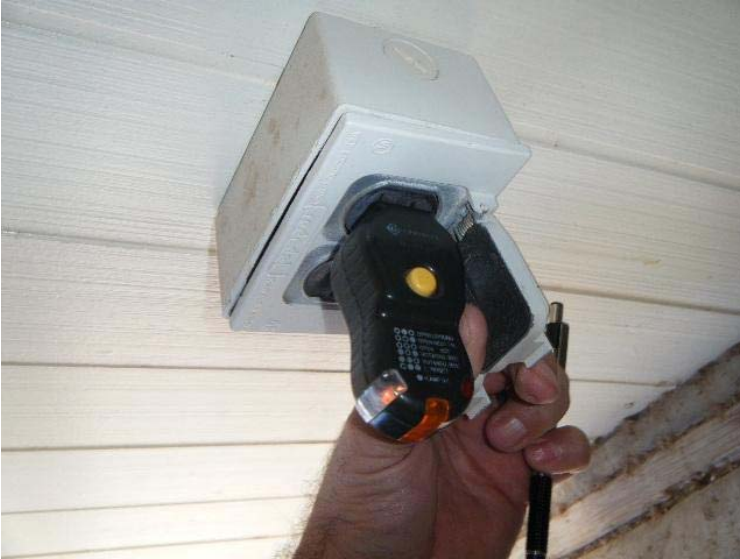
All exterior outlets should be GFCI protected since 1973, Outlet at the front of the shed is also wired backwards I:E Reversed polarity. . Evaluation by a licensed electrician is recommended before close of escrow

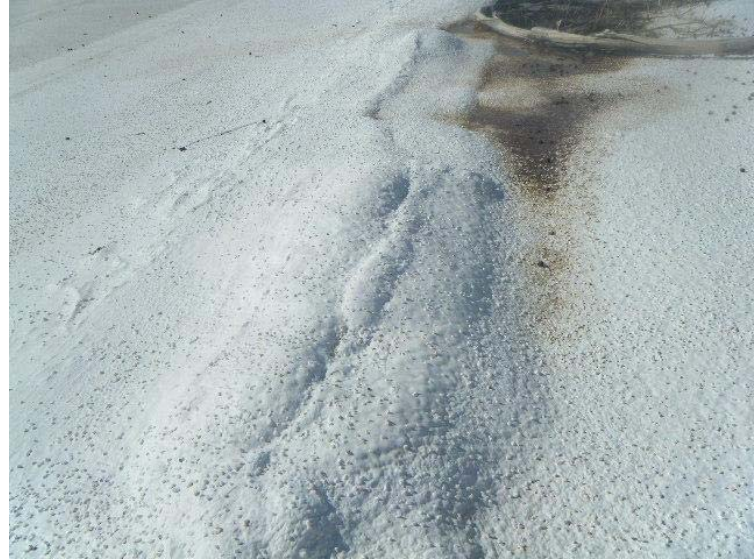
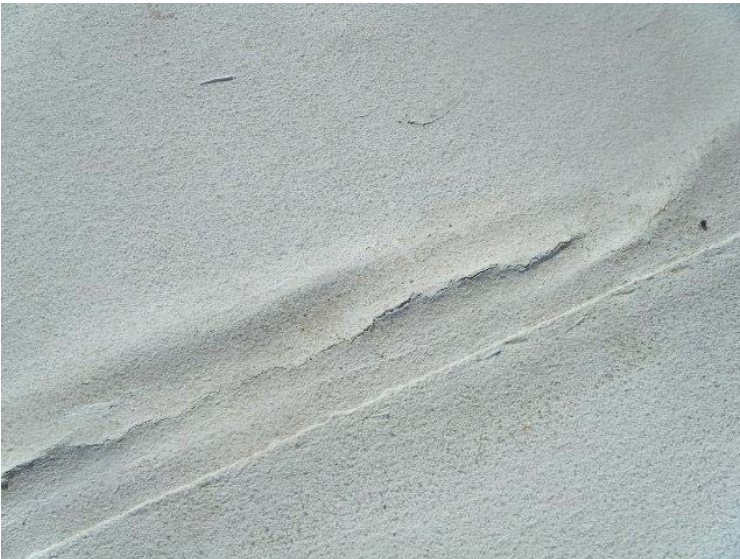
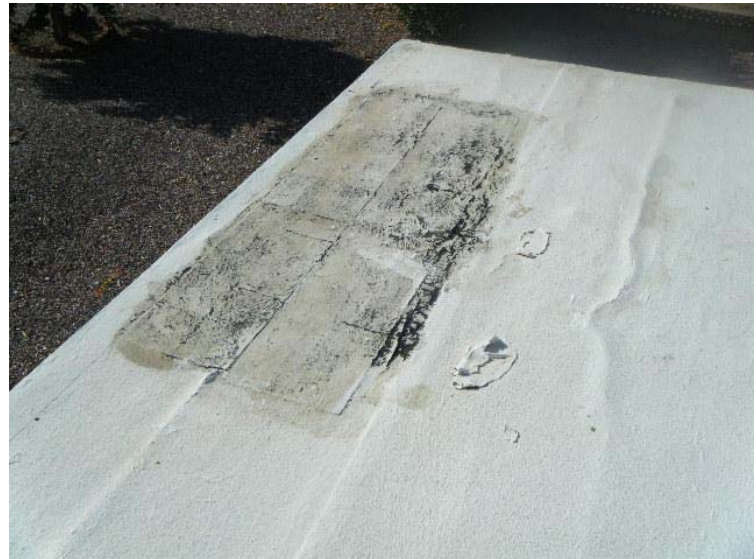
There are bubbled cracked areas at the carport roof, Main house roof has raised areas and also ponding, A qualified roofing contractor is recommended to evaluate and repair before the close of escrow

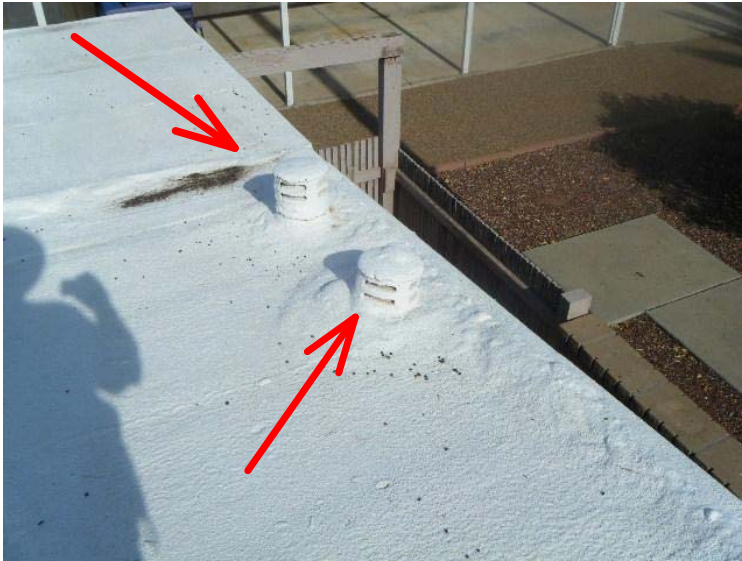
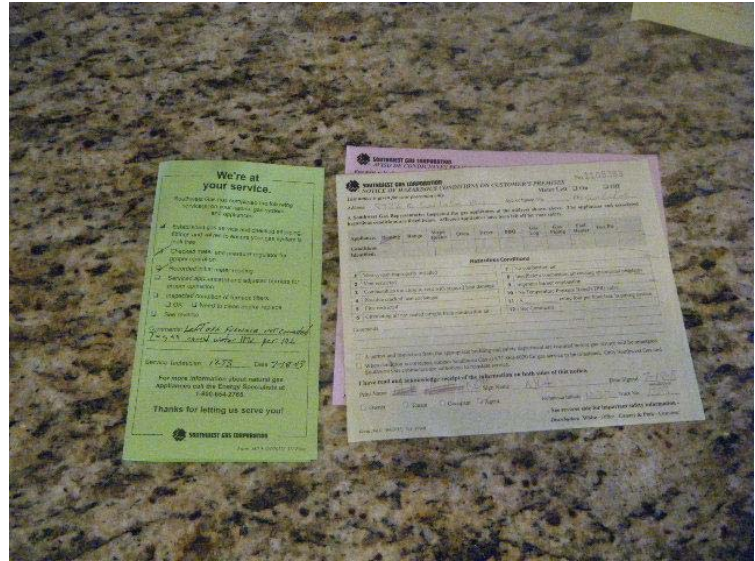
There is a note stating improper venting from the gas company, A licensed plumber is recommended to evaluate and estimate repairs before the close of escrow. Flue pipes may not be safe to use since it is covered with foam, A qualified HVAC / roofing contractor is recommended to evaluate and repair before the close of escrow

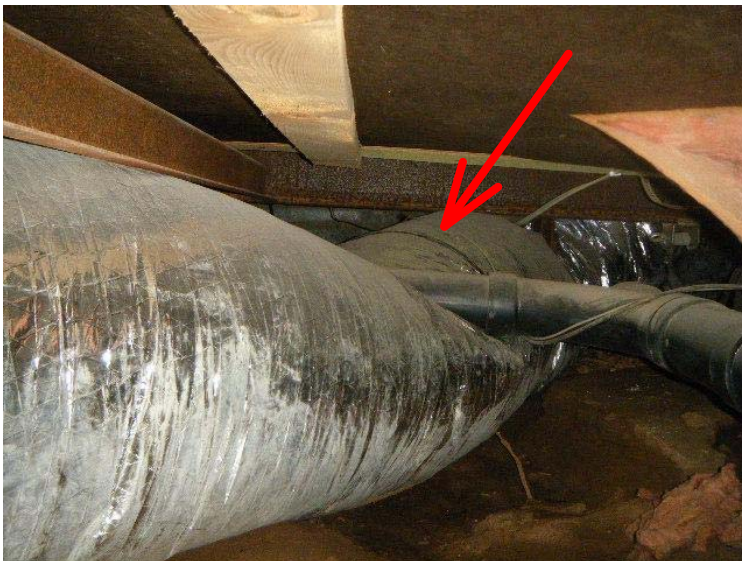
Ducts pipes under unit are on ground. Recommend they be raised above ground and FYI the cold air return duct is partially smashed in the northeast area under the unit

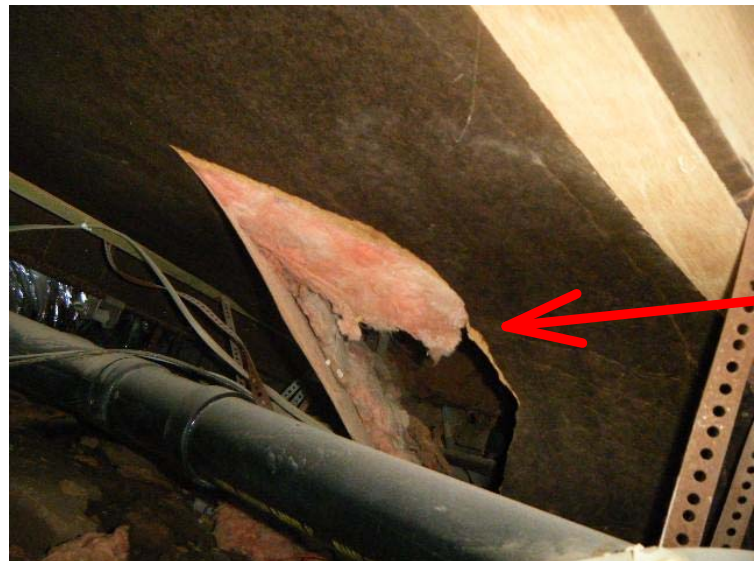
There are areas near the east bathroom with sagging insulation and vapor barrier

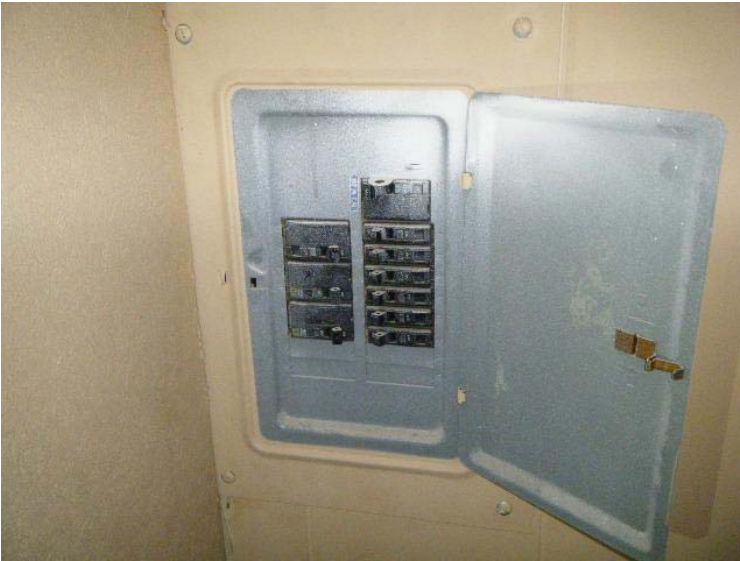
Breakers are not all labeled they should all be labeled at the main post and sub panels

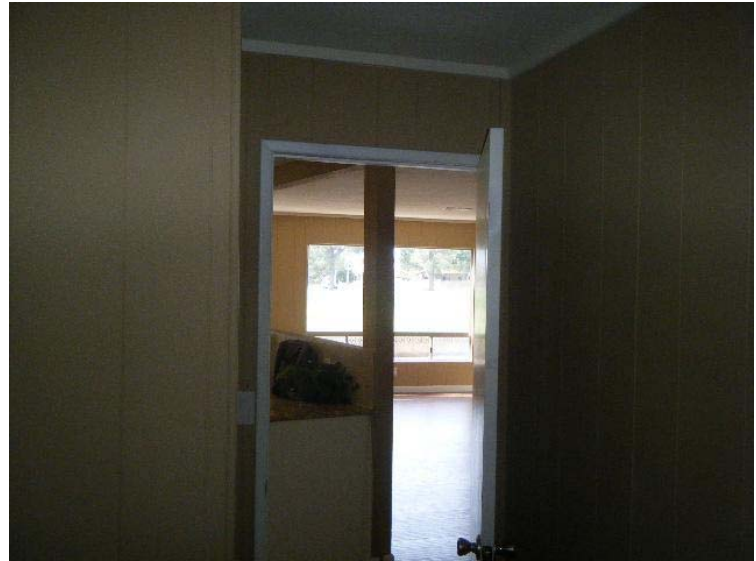
BEdroom Entry doors rub badly and do not close

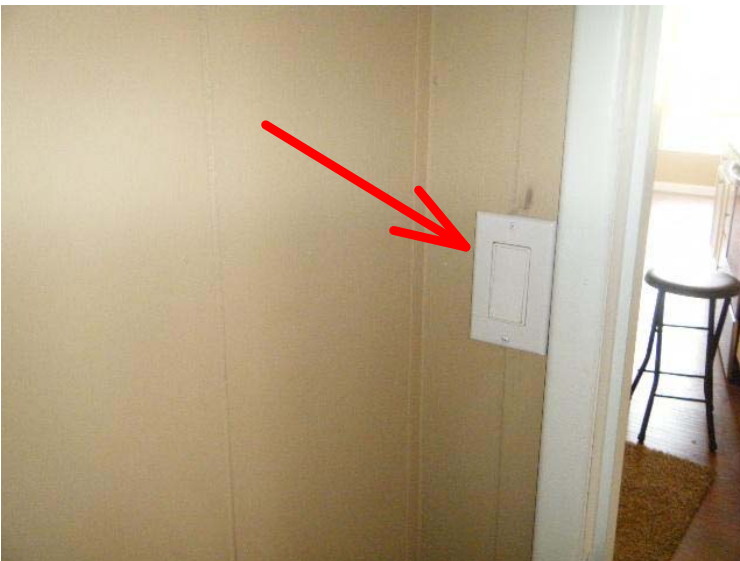
south bedroom Wall switch does not control anything it should have controlled an outlet to plug a lamp in, Evaluation by a licensed electrician is recommended before close of escrow

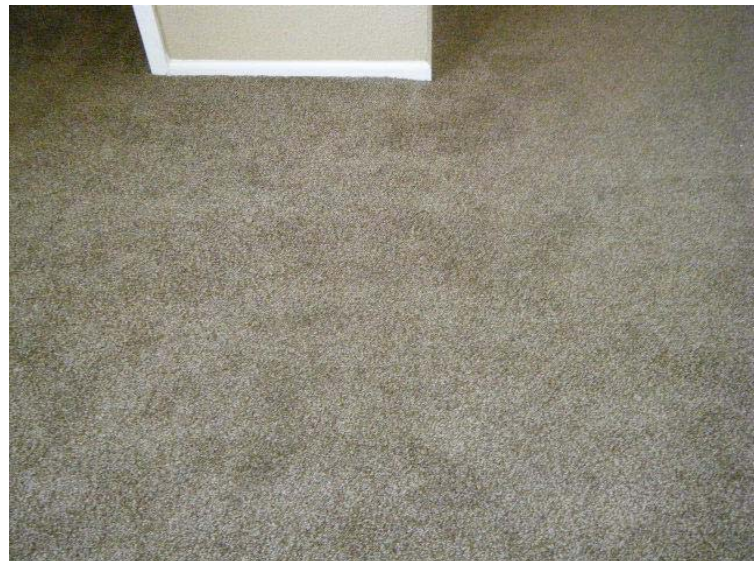
Floor has significantly uneven areas that may be trip hazards

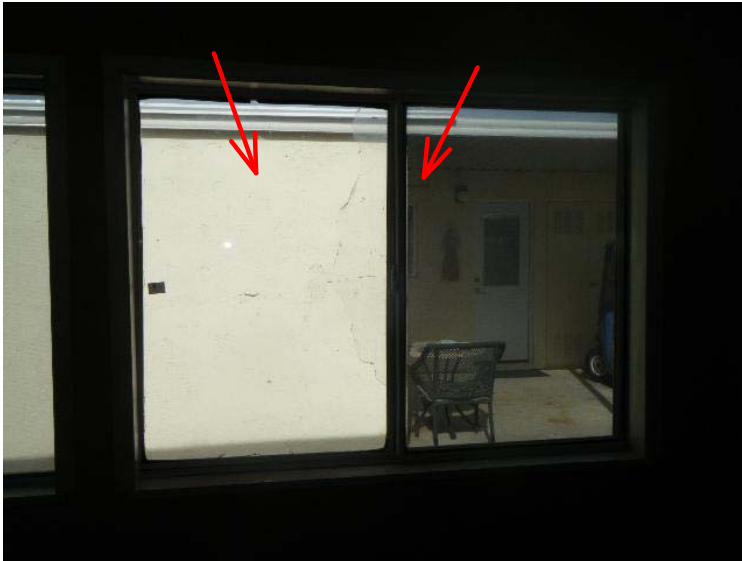
One window will not open and the dual pane of glass is missing and has been replaced with a single piece of plastic / plexiglass, A licensed contractor is recommended to evaluate and estimate repairs prior to close of escrow

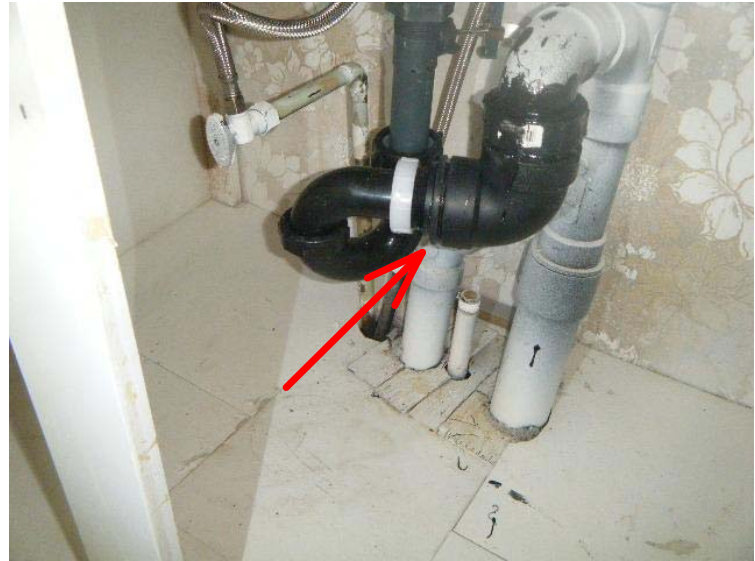
Middle bath Leaking trap/pipes under the sink. A licensed plumber recommended to estimate repairs, before the close of escrow

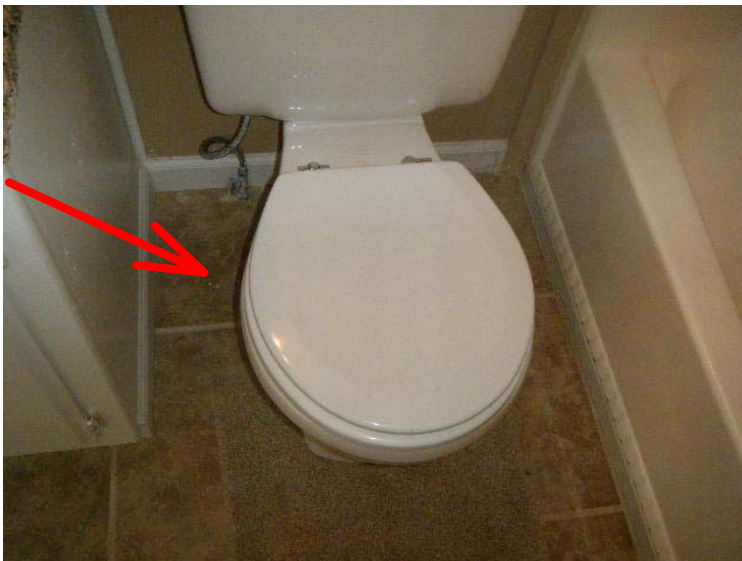
The toilets at both baths are loose at the floor securing properly is recommended

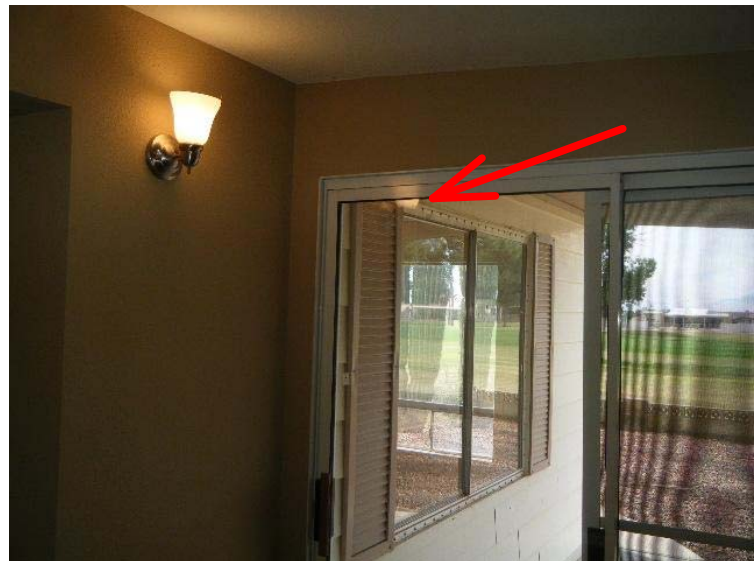
At the northwest patio door there is no exterior light Exterior lighting is typically found at each exterior door and may be a city code requirement, Evaluation by a licensed electrician is recommended before the close of escrow

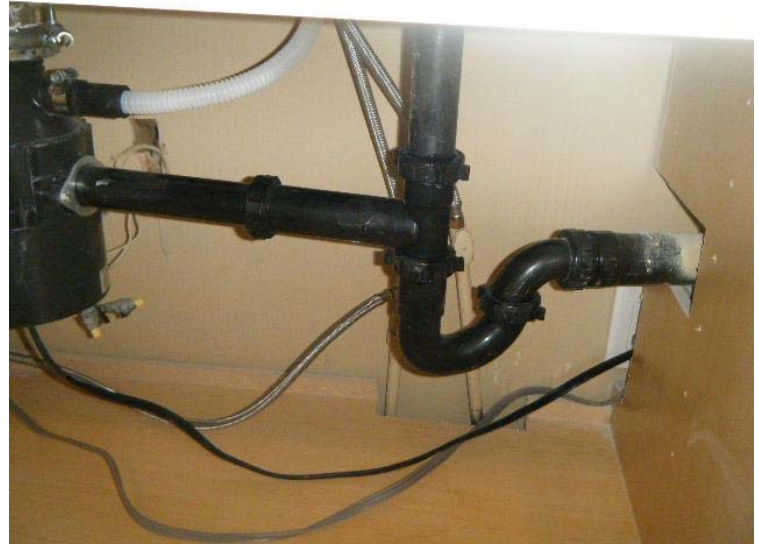
Leaking at drain lines and sink connection, A licensed plumber recommended to estimate repairs, before the close of escrow

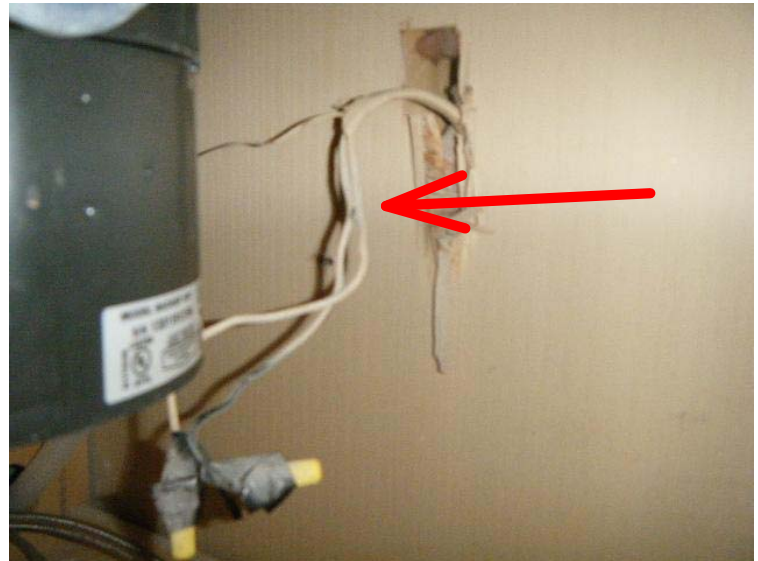
Outlets under sink for disposal / dishwasher are not properly accessible and both halves of the outlet are controlled by a switch meaning the disposal must be turned on for the dishwasher to work. There are also exposed wires under the sink. there is an outlet under the island area next to the stove that should have been removed and properly capped
Evaluation by a licensed electrician is recommended before close of escrow

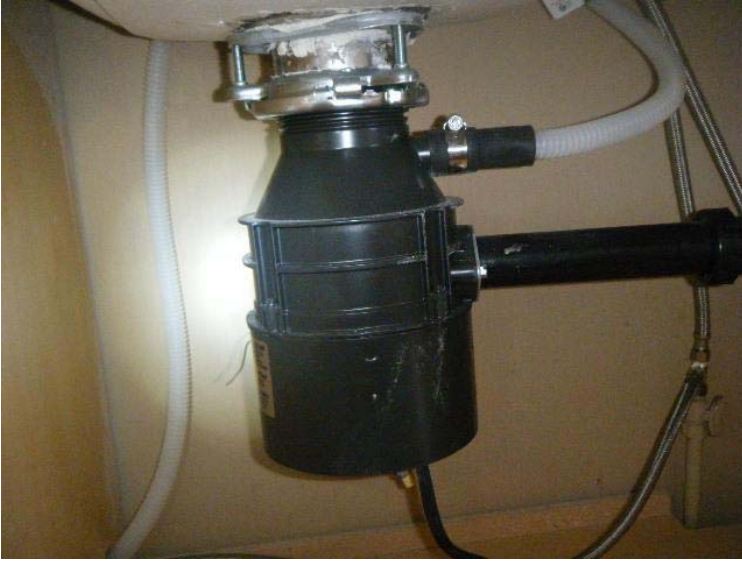
Disposal was very loud it sound like debris in stuck in disposal

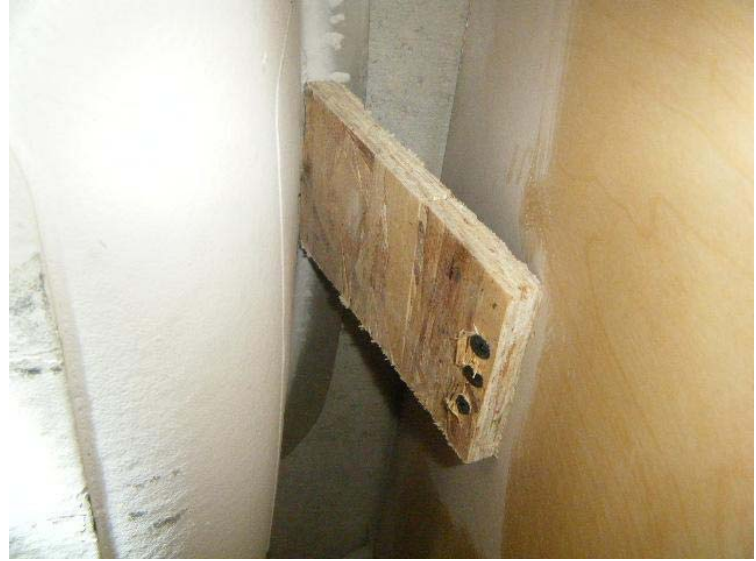
FYI sink is supported wit 4 pieces of OSB / particle board this is not a material that is designed to be load bearing Repairs are recommended

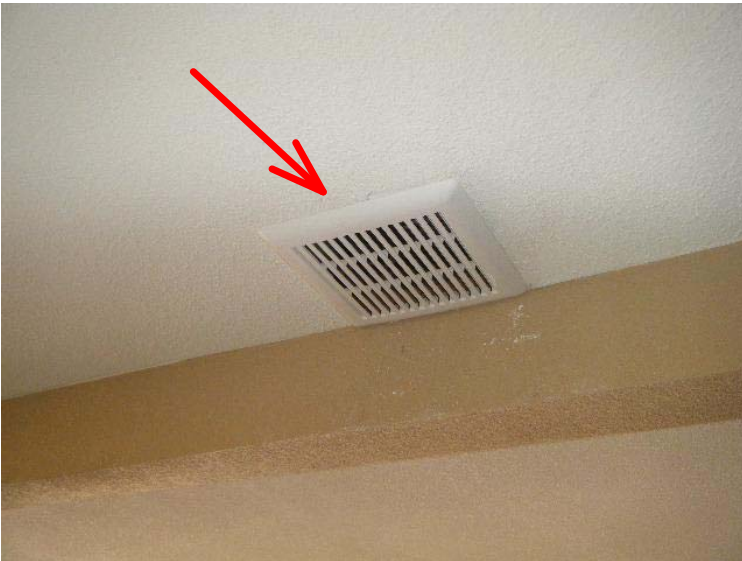
Exhaust fan is missing the motor / insides and I do not know if there is a switch to turn it on, A licensed electrician is recommended to evaluate and estimate repairs prior to close of escrow

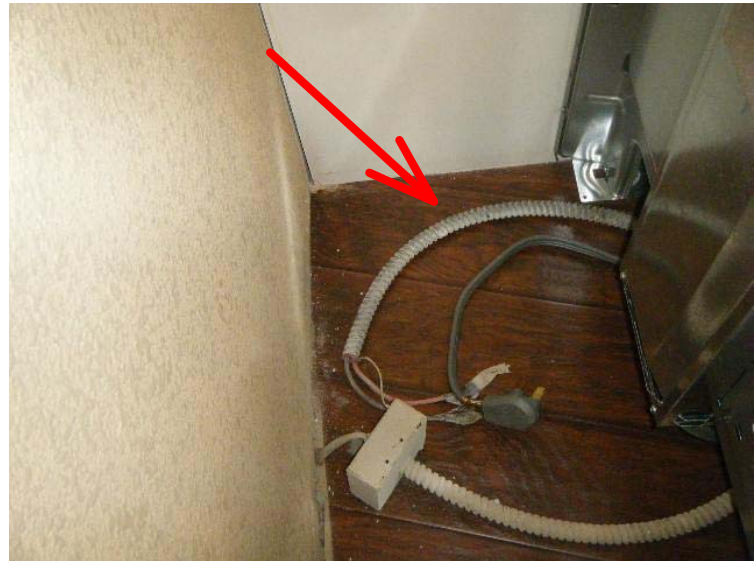
Stove is not working there is currently no electrical outlet, A licensed electrician is recommended to evaluate and estimate repairs prior to close of escrow

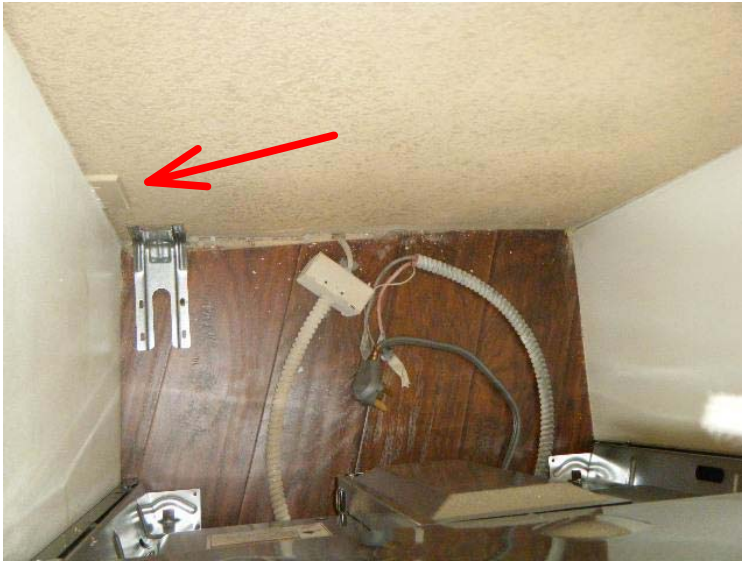
Outlets under sink for disposal / dishwasher are not properly accessible and both halves of the outlet are controlled by a switch meaning the disposal must be turned on for the dishwasher to work. There are also exposed wires under the sink. there is an outlet under the island area next to the stove that should have been removed and properly capped. Evaluation by a licensed electrician is recommended before close of escrow.

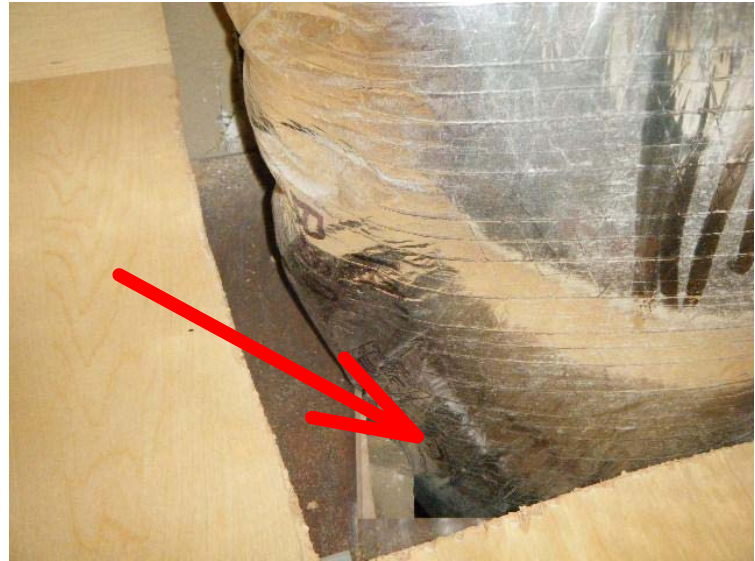
Openings in kitchen floor lead under unit

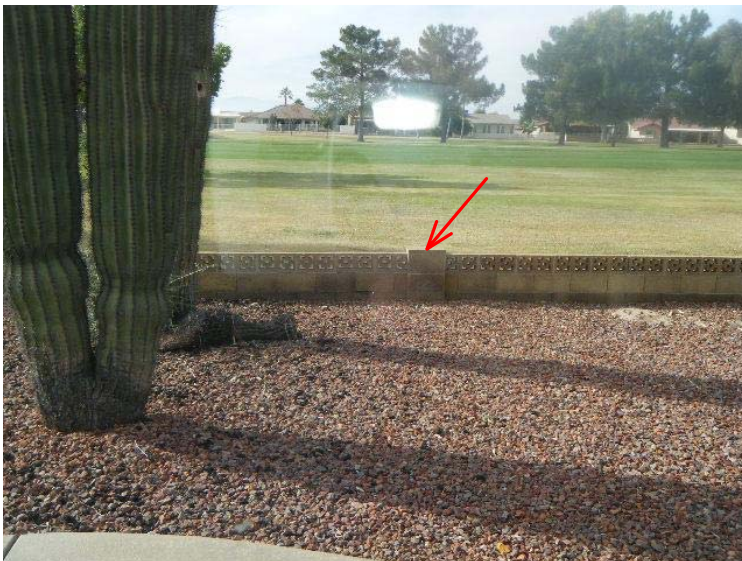
At the rear yard a few Fence post top caps are loose / not secured this is a SAFETY ISSUE recommend repairs prior to close of escrow.
